# ***Safety System***

## Award Winning System - Antiene

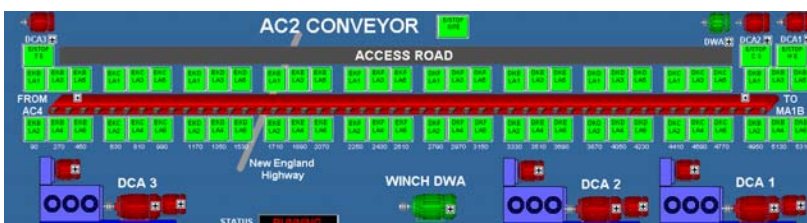
The safety system allowed for communications to the Plant Control Scada where trip information was displayed visually.

SITE E/STOPS	
SITE E/S TOPS	
E/STOP	ERROR CODE
Control Room	2
Upper DS 1	0
Upper DS 2	0
Lower DS	0
SUB 1	0
SUB2	0
SUB3	0
AC2 Head End	0
AC2 Drive Station	0
AC2 Tail End	0
AC4 Head End	0
AC4 Tail End	0
Transfer Tower	0
MA1B	0

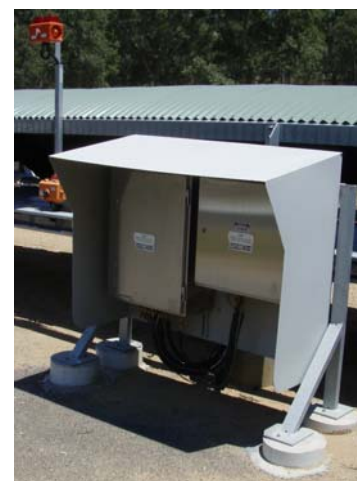
Conveyor prestart sirens and lanyard trip strobes stationed at every lanyard were controlled by the system. A lanyard trip could be visually seen when driving past on the access road.

Lanyard strobes on the opposite side of the conveyor are not readily seen from the access road, the flexibility of the safety system allowed for the tailor modification of the strobes next to the road to flash at an alternate rate to indicate a tripped lanyard on the opposite side.
